*This paper introduces a methodology devised for thermographic inspection of concrete technical condition inside concrete dams. Water infiltration into a dam accelerates the processes of concrete degradation, so temperature fields provide important information about the dynamics of these processes. As a result of the thermal imaging survey of the observation gallery at a historic hydraulic structure, a formalized pattern of the temperature field inside the dam was acquired and the locations of temperature anomalies associated with infiltration were identified. At the leakage points, the water temperature differed from the concrete temperature by 1.0–2.9 °C, indicating different rates of water flow through the water wall and the gallery ceiling. The temperature of the gallery areas with increased infiltration was 1–2 °C higher than the 12.7 °C selected as the reference temperature. When recording the temperature fields, the optical axis of the thermal imager was directed along the gallery, and not perpendicular to the surfaces under study, as in construction thermography. To this end, a methodological approach was devised to eliminate distortions of the resulting thermograms caused

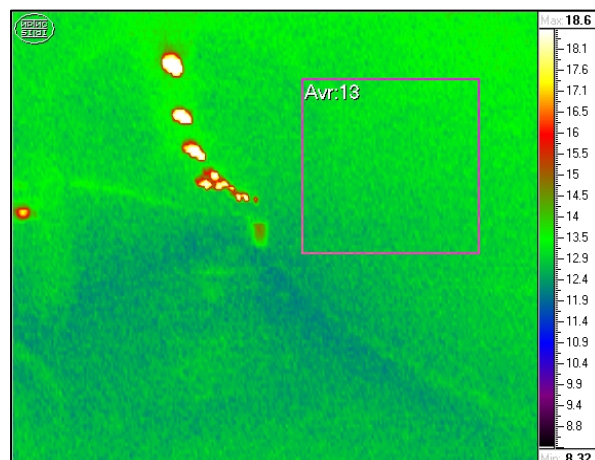
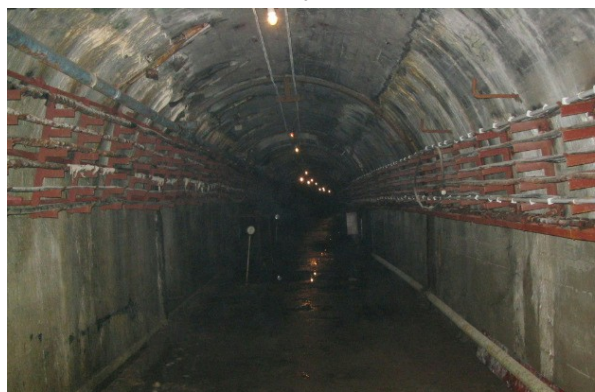
A surface with smooth and dry concrete with a temperature of  $13^\circ\text{C}$ , close to the average temperature inside the gallery, was chosen as the reference area (Fig. 3).

Fig. 3. Reference surface of the dry section of the gallery: a – thermogram; b – visible image

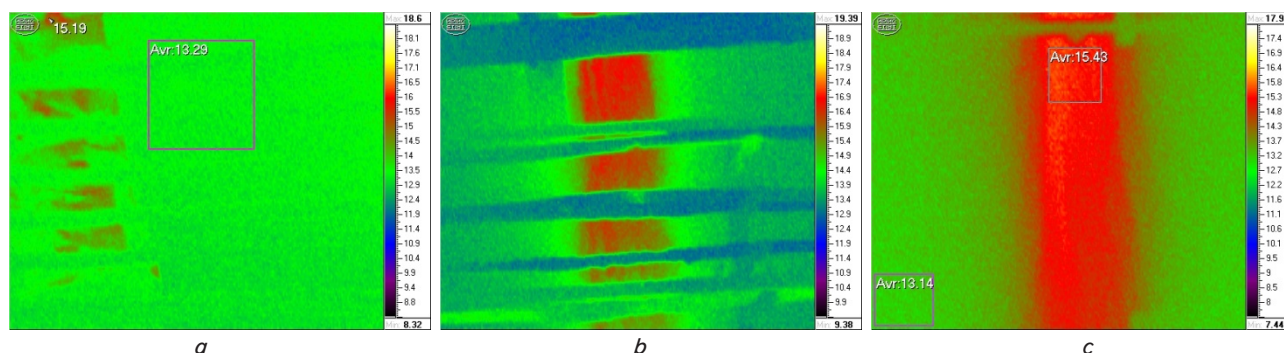
As a result of the survey, water infiltration was observed in some areas of the gallery. The temperature of the water differed in the places of the leaks, which indicated the different speed of its arrival through the water-head wall and the ceiling inside the gallery (Fig. 5) [10].

Analysis of 47 acquired thermograms revealed that the temperature contrast between the leaked water and the walls of the gallery was 1.0–3.0 °C.

Fig. 5. Temperature contrast  $\Delta T$  of the infiltrated water on the water-head wall:  
a –  $\Delta T = 1.9$  °C; b –  $\Delta T = 2.8$  °C; c –  $\Delta T = 2.3$  °C

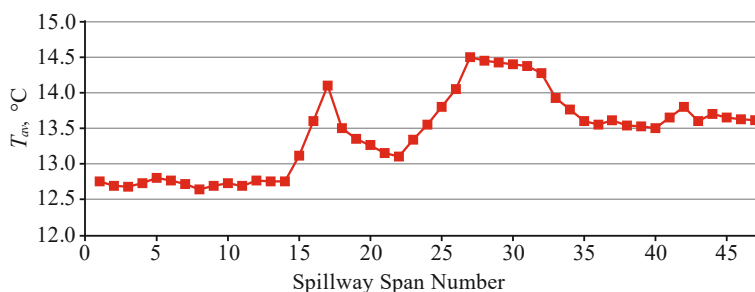
According to Fig. 10, the temperature distribution in the gallery is uneven, which is an indicator of the intensity of infiltration processes. Sections of the gallery adjacent to the left bank of the river (No. 27–45) stand out. They have a temperature criterion higher than the areas adjacent to the right bank. This difference sometimes reaches  $1.8\text{ }^{\circ}\text{C}$ . A noticeable anomaly is observed in the area of section No. 17. A comparison of the results of frame-by-frame processing of the temperature field of the gallery (Fig. 10) with the image of the destroyed part of the Dnipro HPP dam (Fig. 11) revealed the coincidence of abnormally warm areas with restored wartime destruction of the surface part.

Fig. 10. Dependence of the integrated temperature criterion  $T_{av}$  of the gallery surface on the number of spillway span

The higher temperature of the specified sections of the gallery is the result of water infiltration into the body of the dam. Comparing the results of frame-by-frame processing of the temperature field of the upper observation gallery (Fig. 10) with the image of the destroyed dam of the Dnipro HPP (Fig. 11) proved the coincidence of abnormally warm areas with restored wartime destruction of the upper surface part.

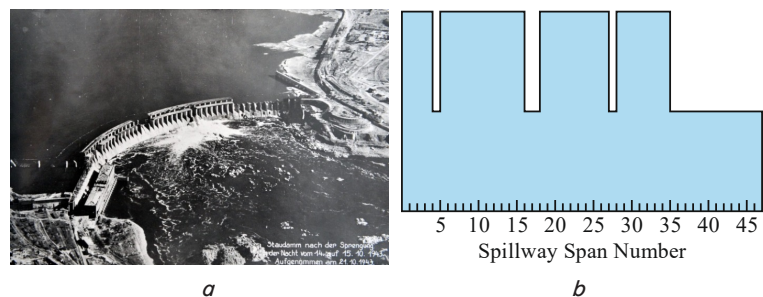
Fig. 11. Dnipro HPP Dam:  
 a – after the explosion on October 15, 1943; b – diagram of destruction of the above-water part of the dam

According to Fig. 11, the following piers of spillway spans were destroyed:
