**METROLOGY AND
METROLOGY
ASSURANCE 2017**

**PROCEEDINGS OF THE
SYMPOSIUM**

THERMAL CONTROL FOR METAL CONDITION TESTING IN PIPELINES OF NUCLEAR POWER PLANT

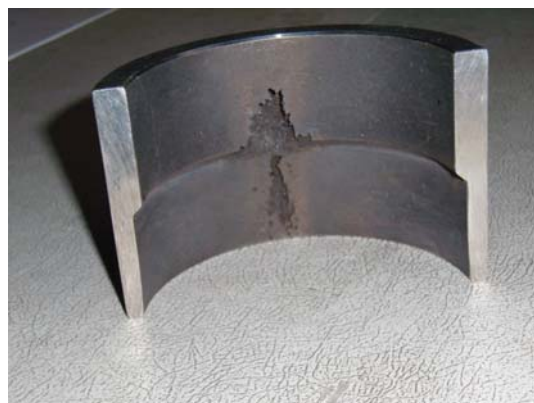
Hydrotechnical equipment is subjected to cavitation erosion. Cavitation erosion is caused by the phenomenon of cavitation that occurs in a moving fluid stream under certain hydraulic conditions. Erosion destruction of the surface during cavitation occurs due to repeated hydraulic impacts of liquid jets on the surface. Fragment of pipeline with defect due to cavitation wear is shown in Fig. 1.

Fig. 1 – Fragment of the pipeline with a cavitation cave (defect).

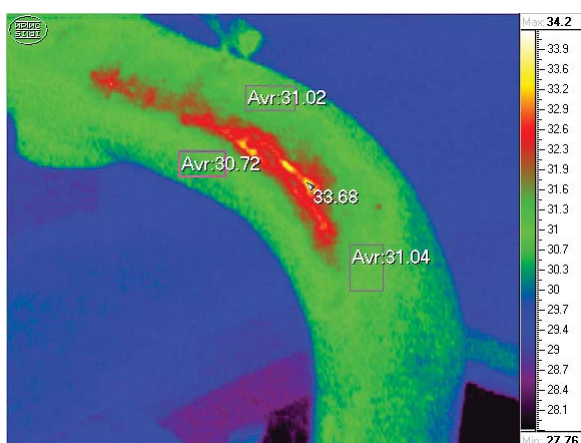
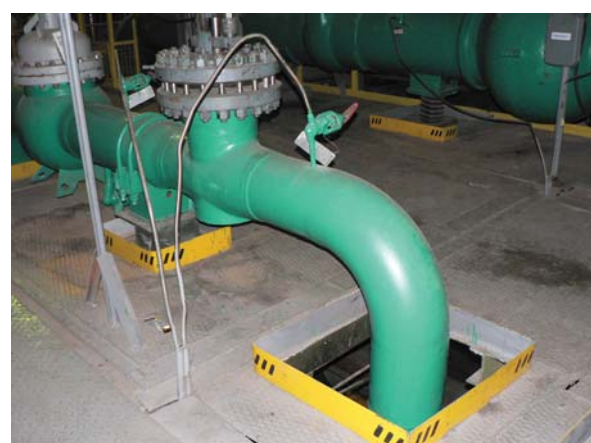
Figure 2 shows a fragment of the pipeline with the identified zone of cavitation erosion. This defect was found on the following grounds:

- The form of the defective zone is not regular and differs from the temperature distortions caused by the external factors studied;

- The defect position does not change when the shooting angle changes;

- The maximum defect temperature differs from the temperature of the rest of the pipe by 2.66°C, which exceeds the levels of other temperature anomalies (see Table 2).

The actuality of detection is supported by the fact that the detected defect is on the turn of the pipeline, where there is a sharp braking of the condensate flow, and such places are most likely for the occurrence of cavitation caverns. The result was confirmed by ultrasound testing.

Fig. 2. The revealed zone of cavitation erosion (defect of pipe wall thinning).
