*This paper introduces a methodology devised for thermographic inspection of concrete technical condition inside concrete dams. Water infiltration into a dam accelerates the processes of concrete degradation, so temperature fields provide important information about the dynamics of these processes. As a result of the thermal imaging survey of the observation gallery at a historic hydraulic structure, a formalized pattern of the temperature field inside the dam was acquired and the locations of temperature anomalies associated with infiltration were identified. At the leakage points, the water temperature differed from the concrete temperature by 1.0–2.9 °C, indicating different rates of water flow through the water wall and the gallery ceiling. The temperature of the gallery areas with increased infiltration was 1–2 °C higher than the 12.7 °C selected as the reference temperature. When recording the temperature fields, the optical axis of the thermal imager was directed along the gallery, and not perpendicular to the surfaces under study, as in construction thermography. To this end, a methodological approach was devised to eliminate distortions of the resulting thermograms caused

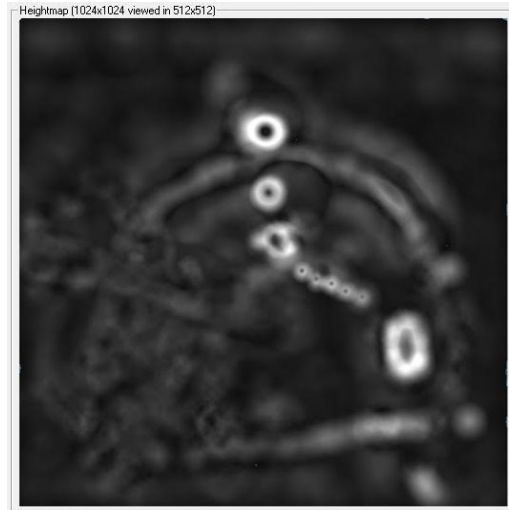
The influence of external heat-emitting sources was reduced by software. Analysis of the elements of the temperature operator  $T_{ij}(x, y, t)$  revealed that the contrasts  $dT_{ij}$  of external heat-emitting sources introduce distortion into the usable signal. Therefore, to suppress this spatial obstacle, the method of computer processing of thermograms using dependences  $dT_{ij}(x, y, t)/dx$  and  $dT_{ij}(x, y, t)/dy$  was used. The map of partial derivatives of the temperature operator, constructed from the thermographic image of a frame of a part of the dam, is shown in Fig. 6.

Fig. 6. Results of thermogram processing by the method of partial derivatives for the purpose of contouring heat-emitting sources

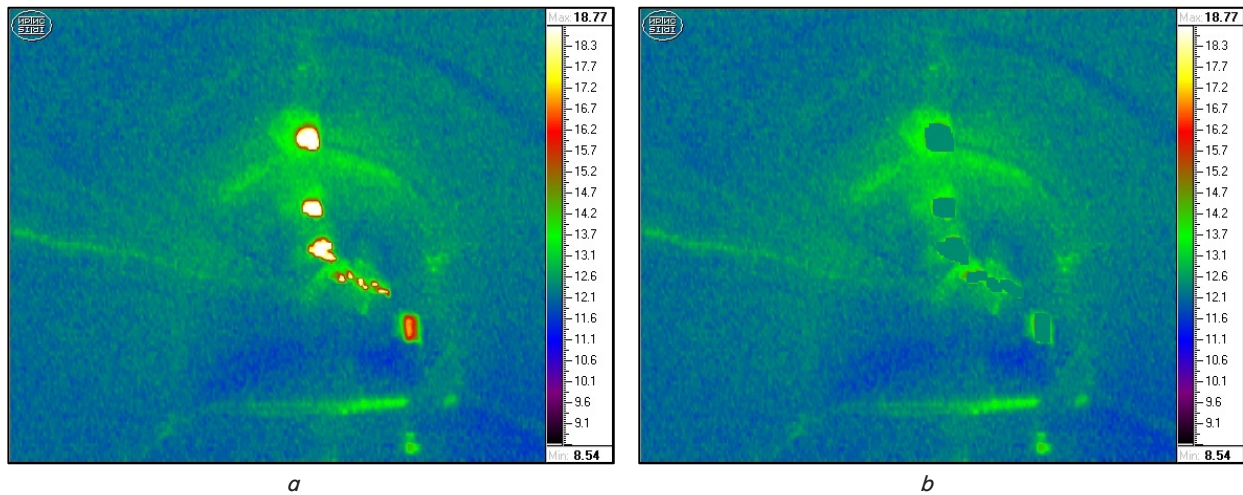
After filtering the acquired image using the dependences shown in Fig. 6, we get the final view of the thermogram after processing (Fig. 7, *b*). Comparison of the acquired thermogram with the original one (Fig. 7, *a*) confirms the fact that the influence of external heat-emitting sources has significantly decreased after processing. Quantitative assessment shows a decrease in the interference signal by more than 2.5 times [12, 13].

Fig. 7. Eliminating the influence of external sources of radiation: *a* – initial thermogram; *b* – processed thermogram

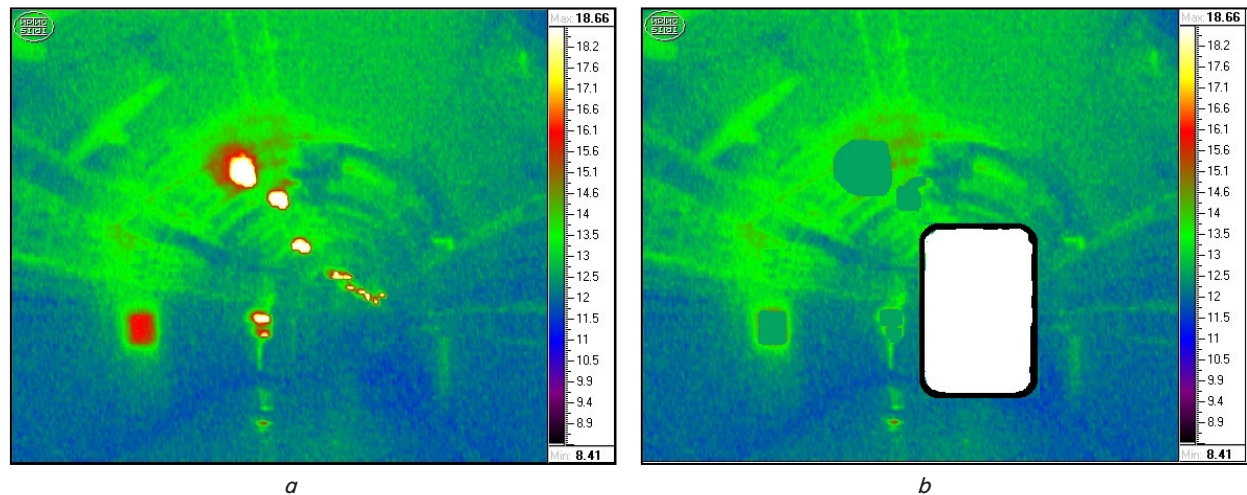
Fig. 9. Thermogram of the section of the upper gallery with angular displacement:  
 a – untreated,  $T_{av}=13.6\text{ }^{\circ}\text{C}$ ; b – after processing,  $T_{av}=12.7\text{ }^{\circ}\text{C}$

Fig. 9 demonstrates that as a result of thermogram processing, the integrated temperature criterion  $T_{av}$  turned out to be less than that on the unprocessed one because of the exclusion of influence of lighting lamps and electrical distribution equipment, as well as taking into account the mask. After processing the entire sequence of thermograms, the difference between the average temperatures of treated and untreated ones was  $0.7\text{--}2.8\text{ }^{\circ}\text{C}$ .
